# Corrosion damage diagnosis of a reinforced concrete beam after 40 years natural exposure in marine environment

A detailed investigation of the chloride induced corrosion damage was performed on a 40 years old reinforced concrete beam exposed in marine environment. Visual observations, electrochemical measurements, carbonation depth, total chloride content were carried out. Half-cell potential measurements were used to locate corrosion areas. It appeared that the interpretation based on gradient of the potential was in good concordance with real state of damage. Complementary destructive methods are applied to observe the real corrosion state of steel rebars and characterize the corrosion products and the steel/concrete interface (optical and electronical microscopy tools (XRD, SEM, EDS and  $\mu$ -Raman).

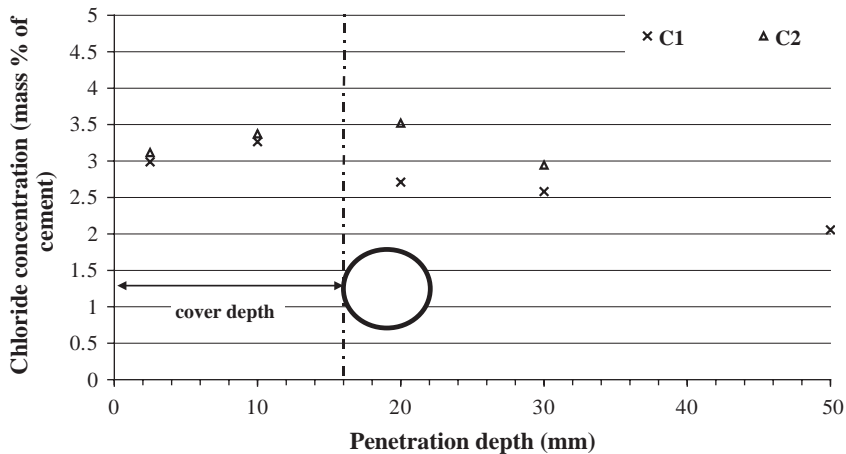
Fig. 4. Acid-soluble chloride concentration (the cover depth for steel is indicated on the graph).

Fig. 4 presents the average profiles of the “total” chloride ion concentration measured at two locations along the beam. A characteristic profile of a concrete structure exposed in tidal marine environment is observed with a maximum value at about 10 mm from the top surface and a slight decrease within bulk structure [22]. At the reinforcing bars depth, the measured values (2.5–3.5% cement mass) exceed the threshold limit (0.5–1.5%) generally pointed out in literature [11,23]. It is generally assumed that for higher chloride content the corrosion by chlorides ions can be initiated at the rebars surface. These results highlight that active corrosion due to chloride ingress can take place at reinforcing steel surface.

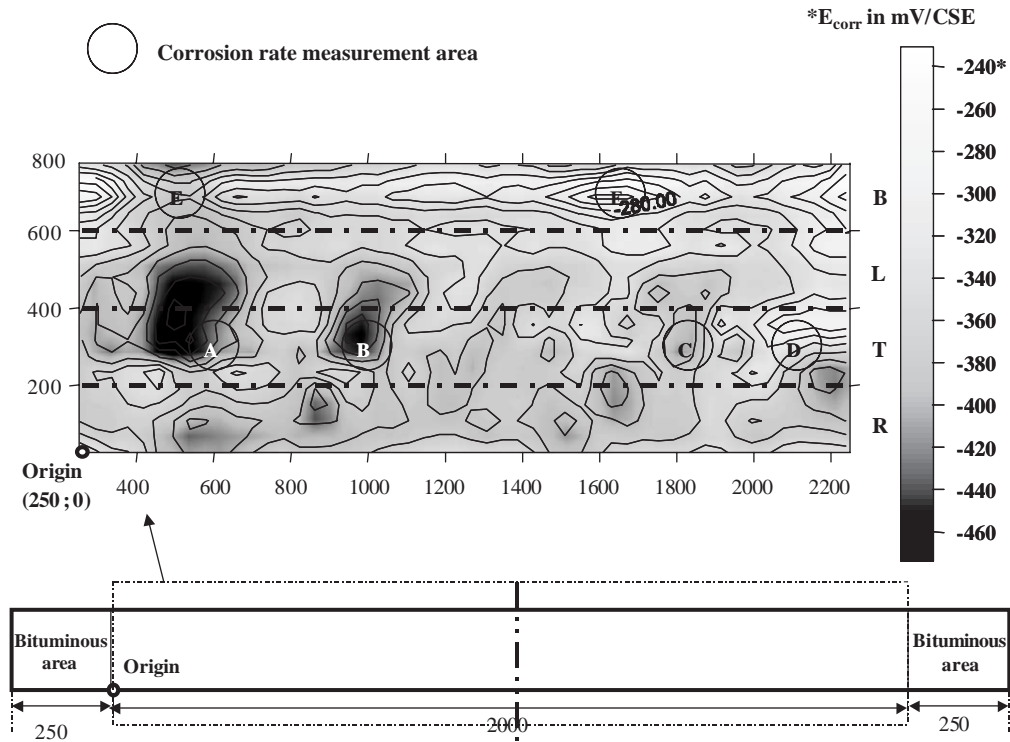
Fig. 5. Half-cell potential map—overview of the 4 sides.

Fig. 5 illustrates the potential map (the equi-potential contour line plots are indicated) according to a developed view of the beam (dark areas correspond to the most negative potentials). Excepted some spots in the lower part of the beam (side B), half-cell potential readings mainly show absolute values more negative than  $-0.35$  V (/CSE). Considering ASTM C876-9 norm [24] that proposes a correlation between absolute potential values and corrosion activity, this would indicate a high active corrosion probability in the vicinity of all reinforcing bars within structure. However, several studies highlighted that various parameters can modify these absolute potential values without expressing a modification of the corrosion degree at steel surface [14,25]. So an interpretation based on the use of the absolute half-cell potential values may lead to erroneous results on locations of “high-probability” corrosion activity within reinforced concrete structure. That is why we prefer apply the Rilem recommendations which suggest to interpret the half-cell potential values by considering the different potential ranges [14]. The more anodic areas

which could correspond to the areas with the highest corrosion probability are well-identified. Considering potential readings collected on the beam (Fig. 5), only two significant localized anodic areas could be determined respectively at 600 and 1000 mm along the beam on Side L and Side T. Some localized anodic areas can be identified along the beam on Side R.

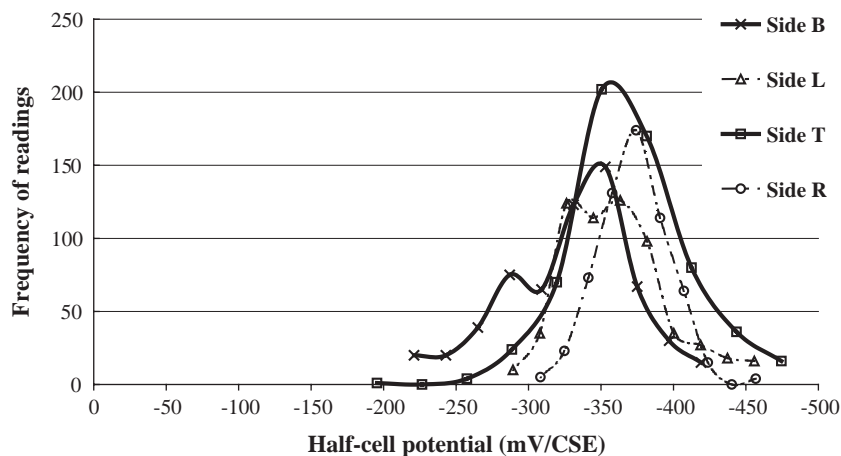
Fig. 6. Frequency distribution of half-cell potential data for the 4 sides of the beam.

A complementary way to study half-cell potential readings consists in a statistical analysis. Such analysis allows to compare the corrosion activity of the 4 beam sides. The frequency distributions are illustrated on Fig. 6. Profiles of potential distributions are very close and do not enable to conclude on a different corrosion activity on the four beam sides.

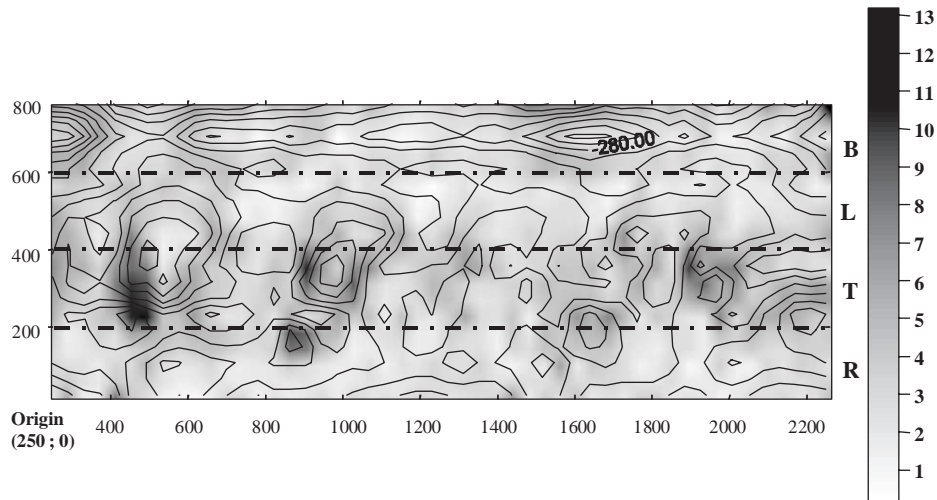
Fig. 7. Potential gradient map—overview of the 4 sides.

For this purpose, half-cell potential values are used to evaluate the potential gradient (expressed in millivolts per centimeter). Fig. 7 illustrates the potential gradient map (colour plot) (equi-contour line plot represents the potential values). According to this representation, the highest gradient values (corresponding to dark areas) are mainly located in the tensile area of the beam (Side T and in the upper part of the sides L and R). Some localized spots are also noted in the compressive area.

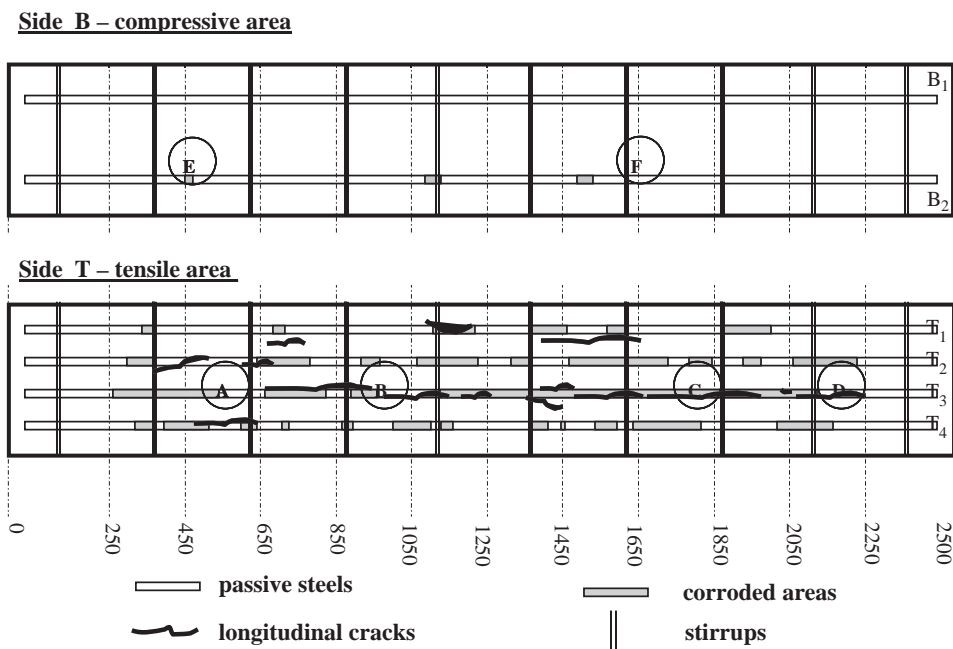
Fig. 10. Distribution of corroded areas on the length of beam for reinforcements in concrete compressive (Side B) and tensile (Side T) areas.

Fig. 10 represents the corrosion spots identified on rebars located in the upper and the lower beam sides. These observations confirm a heterogeneous distribution of corroded areas along the beam (localized corrosion due to chloride ion presence). Moreover measurements of diameter loss are presented in Fig. 11. They confirmed the heterogeneity of the corrosion pattern. A diameter loss of about 30% is noted on the upper part of the beam (equivalent to approximately 50% of steel cross-section). On lower part of the beam (Side B), diameter loss does not exceed 2%. Fig. 12 illustrates the localized corrosion on a length of rebar after removing the corrosion products. These results are in accordance with the corrosion rate evaluation: the corrosion degree is more important in the tensile area of the beam than in its compressive area.

By comparing the longitudinal cracks locations with the corroded areas really observed at steel rebars surface (as indicated in Fig. 10), the correlation between cracks and attack penetration is confirmed as suggested by Rodriguez et al. [26] and Vidal et al. [13] who proposed empirical models to correlate the cracking width and rebar corrosion (cross-section loss). However, this method presents some limits. First, the corrosion areas can be located only when corrosion processes induce enough expansive products to create cracking on the concrete faces. Moreover, existing models to correlate crack width and corrosion are based on empirical relationship in controlled accelerated exposure conditions. More studies have to be performed to generalize models to other exposure conditions (particularly in long term exposure and natural environment).

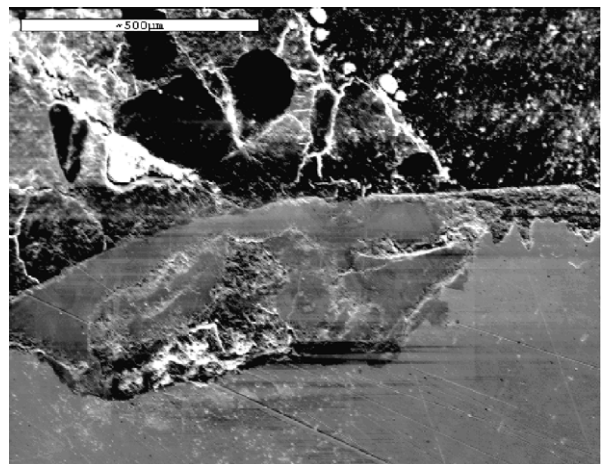
Fig. 19. SEM photography of steel/concrete interface for Sample B — Loc.2 (high-corrosion level).

concrete was observed at the vicinity of the steel/concrete interface near Loc.2.

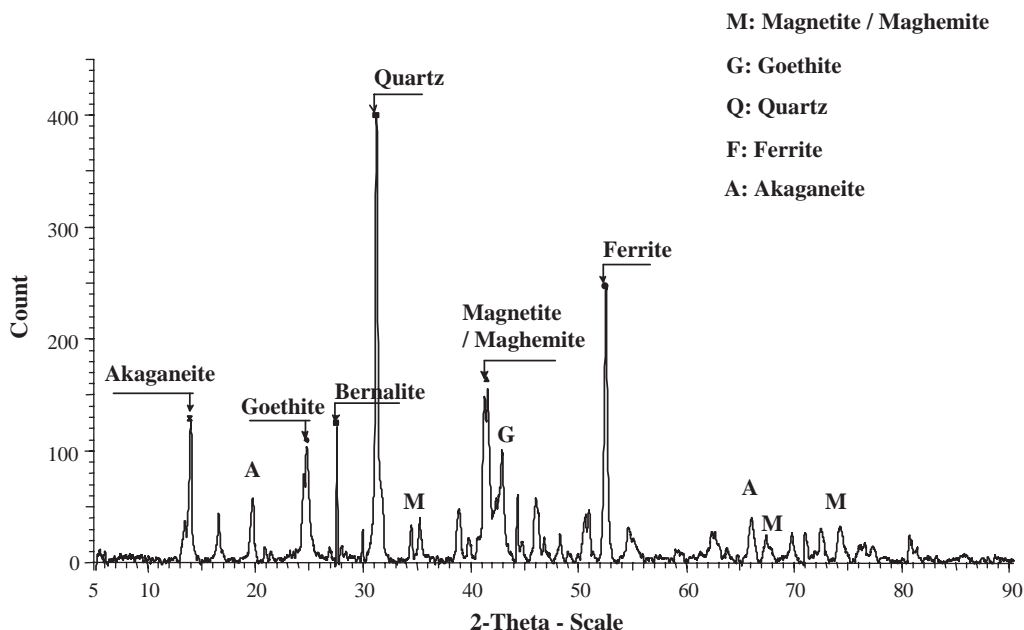
Fig. 22. XRD spectra for “high-corroded” area (Sample B).

**4.5.2.2. XRD analysis.** Corrosion products are taken from a 4 cm length rebar with a localized corrosion layer in surface (Sample B, high-corrosion level) and put in powder. As previously observed, results show dominant peaks of

goethite ( $\alpha$ -FeOOH) and iron oxide (magnetite ( $\text{Fe}_3\text{O}_4$ ) or maghemite ( $\gamma$ - $\text{Fe}_2\text{O}_3$ )) (Fig. 22). Peaks of Quartz due to presence of concrete is observed. Moreover, a significant “akaganeite” peak ( $\beta$ -FOOH) is noticed. This phase is characteristic of chloride ions presence in the corrosion process [30]. Some secondary elements as bernalite ( $\text{Fe}(\text{OH})_3$ ) are also observed.
